SKIN ULCERATION AND EXPOSURE OF HEROGRAFT

¹ Angiology and Vascular Surgery Department, Centro Hospitalar e Universitário de Coimbra, E.P.E.

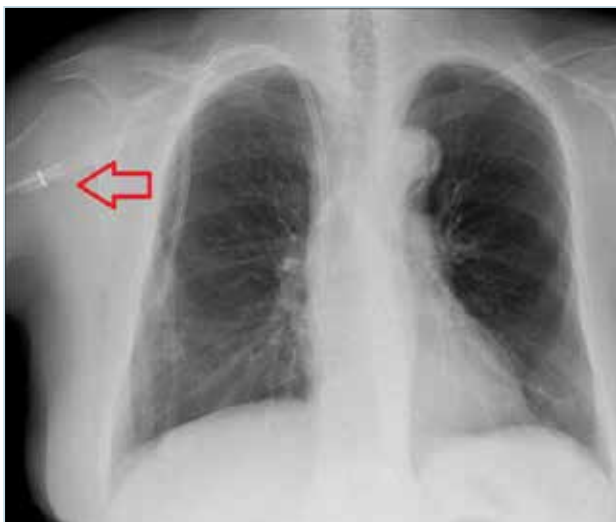
Figure 1

Over time the graft migrated distally (Figure 1), and patient developed skin ulceration and graft exposition (Figure 2). No important weight loss was noted. Arterial graft was removed surgically and she had kidney transplantation.

Arterial graft removal when HeRO graft is abandoned should be considered.
